Displacement ventilation in the museum environment: a case study

SUMMARY

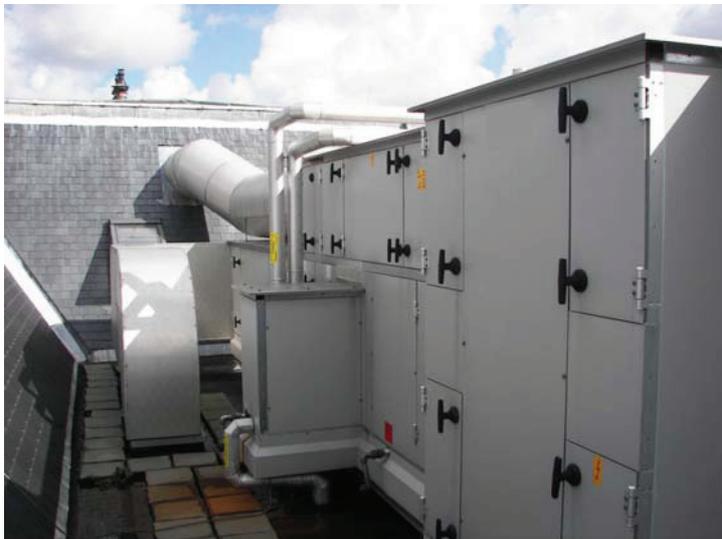
Figure 1. The air handling unit is placed on the roof.

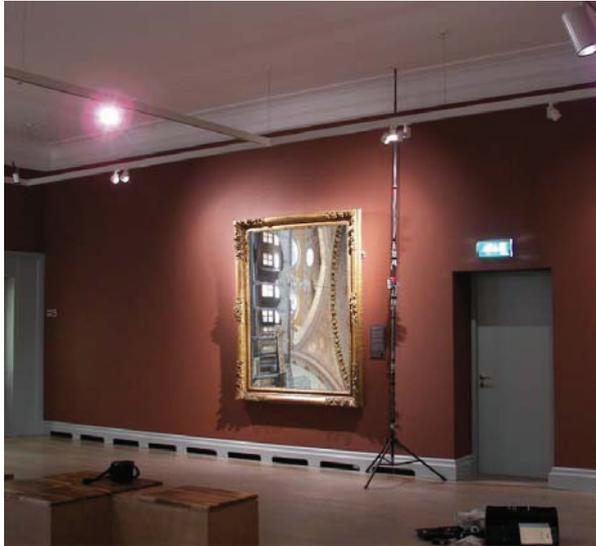
The telemetric measurement system consisted of wireless transmitters which measured temperature and Rh. The data measured by the sensors were sent to the centrally positioned data logger where the data was stored. The connection between data logger and laboratory of the TU/e was performed via cell phone, making it possible to remotely monitor measurements in real time. The temperature gradient was measured in one position in the museum. This measurement was performed using a tripod on which 8 temperature sensors were attached at different levels (see Figure 6).

Figure 6. Test set up for measuring temperature stratification at room level.
