When an HVAC design becomes reality: Investigating the impact of floor heating on the indoor climate risks in a contemporary art museum

KEYWORDS: indoor climate, underfloor heating, HVAC design, temperature gradients, relative humidity gradients, building renovation and extension, exhibition spaces

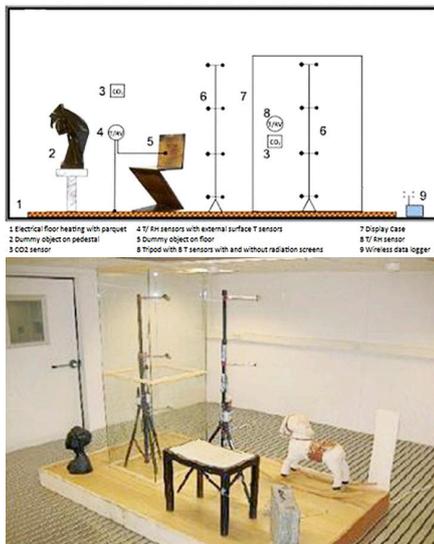
Figure 1

Top: schematic presentation of the experimental setup. Bottom: real-time setup in the climate chamber

For the experimental setup (see Figure 1), a floor with underfloor heating (2.5 × 1.5 m²) was constructed using the same materials – wooden parquet on concrete – as was planned for the future museum building. The test floor had a limited surface area (about 3.75 m²) and consisted of an electrical underfloor heating system adjusted to achieve a stable surface temperature of about 25°C with a fluctuation of 0.5°C, as in the manufacturer's specifications.

A prototype of the display case, then still in its design phase, was made according to the case design specifications. The dimensions of the prototype were 1.85 × 0.6 × 0.6 m³ (H × W × D) resulting in a volume of about 0.65 m³. As the metal frame was not yet in production at the time, a wooden frame, with a profile very similar to the original design, was used and subsequently covered with metal tape. The display case was composed of nine separate glass plates (5 mm in thickness) and three wooden profiles into which the glass plates slotted. This resulted in a display case with three sections: a lower, middle, and upper section. As in the original design, no base shelving was placed in the case; the lower part of the display case was therefore in open connection with the heated floor. All joints and gaps in the display case were sealed with aluminum tape to study the temperature gradient in the showcase.

Hygrothermal stratification was measured by combined RH/temperature sensors attached to tripods. The air temperature was measured at four different levels inside and outside the display case: at 0.1, 0.6, 1.1 and 1.6 meters above the ground. The temperature sensors were fitted with radiation screens so that the air temperature could be measured

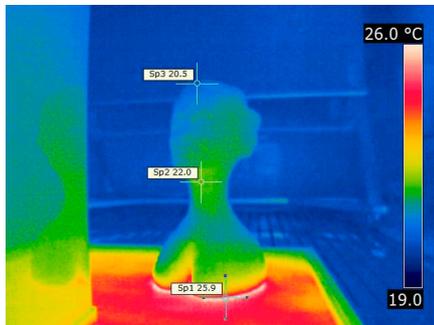
Figure 2
Thermal image of a dummy object placed directly on the heated floor

Figure 2 shows an infrared image of a dummy artwork (polystyrene covered with a layer of modeling wax) placed directly on the floor. The surface temperature of the floor was 25°C. The image clearly shows a temperature gradient over the object of 20°C at the top and approximately 26°C at the bottom. It can also be noted that the object was locally exposed to heat radiation of up to 22°C, for example in the neck area.

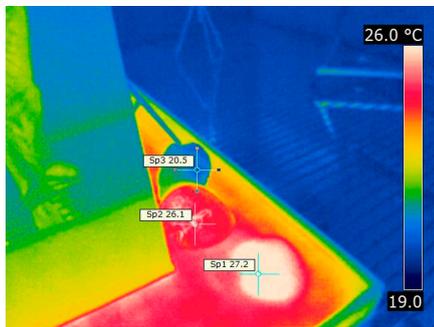
Figure 3
Thermal image of a dummy object placed directly on the heated floor shortly after it has been turned on its side

When the object was turned on its side (Figure 3), a clear temperature increase at the contact surface was visible; the surface temperature of the floor where the bust had been placed was then approximately 27°C. The contact temperature under the bust was higher than the overall surface temperature of the floor. This was caused by the thermal insulation of the object, which prevented the local emission of radiation and convective cooling.

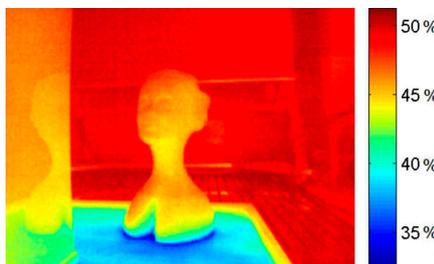
Figure 4
Hygrogram of the bust, calculated from the thermograph in Figure 2

The local RH was calculated using the local temperatures (Schellen 2002) and calculated specific humidity, assuming that the specific humidity in the room was uniformly distributed. The thermal image of the object was then translated into a hygrogram.

The hygrogram in Figure 4 shows that the surface RH of the object placed directly on the floor was approximately 33% near the floor and 50% near the top. This produced a visible RH difference of about 17% between the lower and upper part of the object. This kind of gradient is considered to be a significant risk for hygroscopic objects such as wood. Local heating will lead to local drying of hygroscopic materials due to low surface RH. Due to local drying, stresses are expected to form within the objects which could lead to (local) cracking, warping, or splitting. Furthermore, due to the higher local temperatures, accelerated chemical degradation is expected, which presents a potential threat to chemically instable objects.

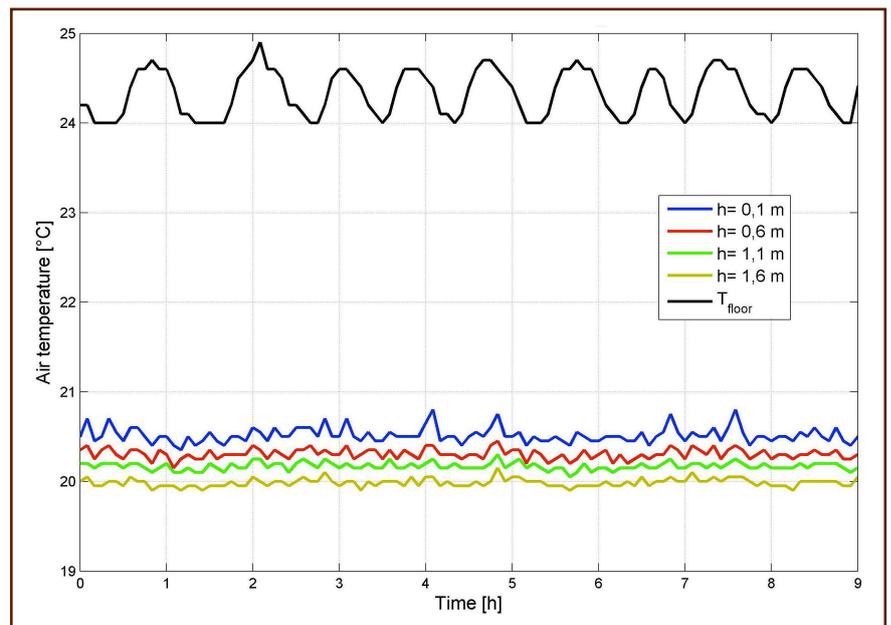
Figure 5
Temperature profiles at different heights outside the showcase with heating on

The first measurement results (heating off and case unsealed) showed temperature gradients that were of roughly the same magnitude outside as inside the unsealed display case. Obviously, switching on the underfloor heating resulted in a temperature gradient, both outside (see Figure 5) and inside the unsealed display case (Figure 6). The lowest sensor outside the display case (0.1 m above the floor) showed a temperature of approximately

20.5°C, while the sensor at the same height inside the display case showed a temperature of approximately 21.7°C. The highest sensor (1.6 m) outside the display case showed approximately 20.0°C and inside approximately 21.1°C. Generally, the temperature inside the unsealed display case was about 1°C higher than outside.

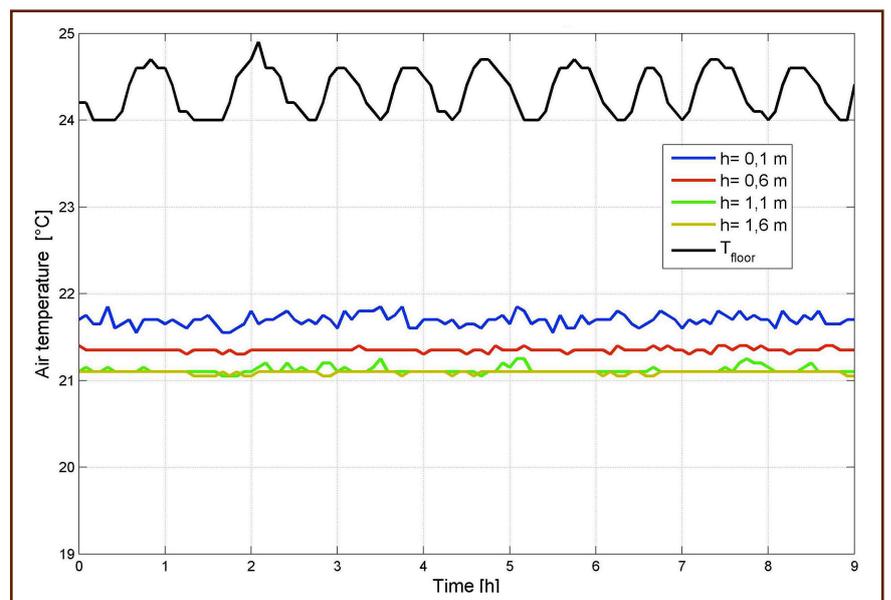
Figure 6
Temperature at different heights in the unsealed display case with heating on

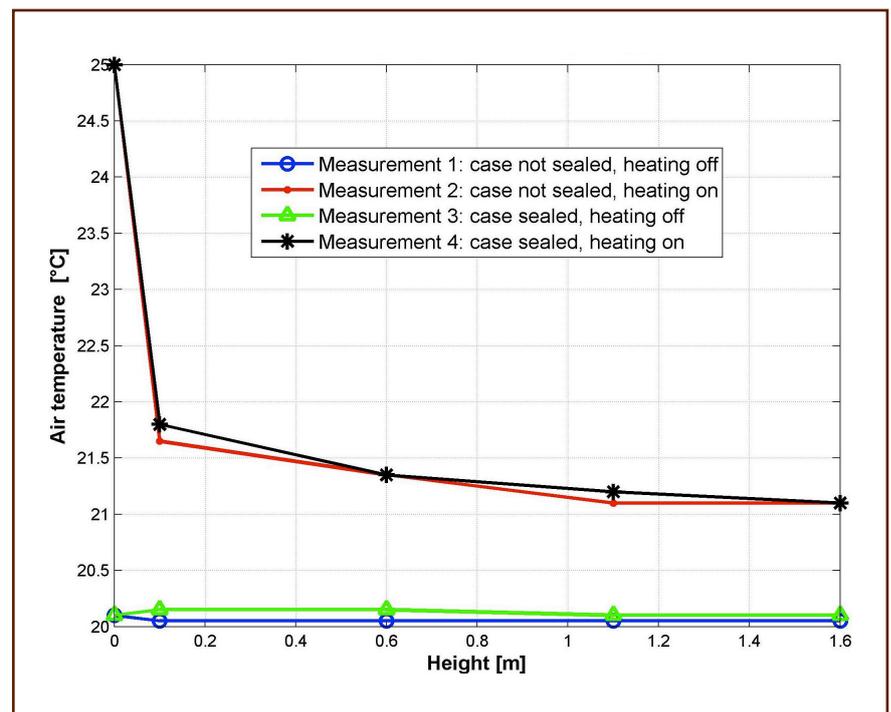
Figure 7
Air temperature profiles inside the showcase for the four experimental situations (Table 1)

Sealing the display case did not change the location or shape of the temperature gradient; this can be clearly seen when comparing the black and red line and the green and blue curve in Figure 7. Due to the underfloor heating, the highest temperature and largest temperature gradient in the case was measured closest to floor level (0.1 m above the floor). Above 1.1 m, air conditions were practically uniform. This also applied to the measurements taken outside the showcase.

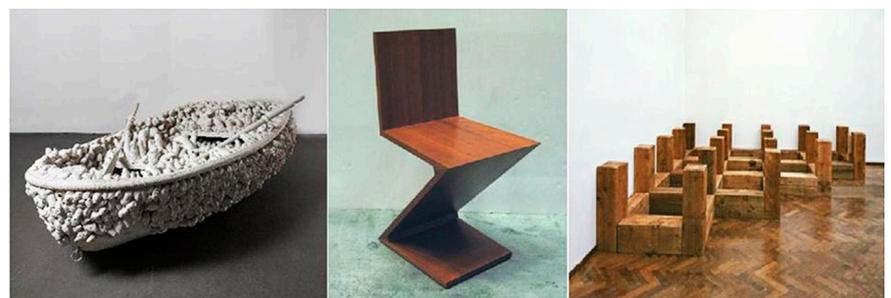
Figure 8
Left: Yayoi Kusama's *Aggregation: One Thousand Boats Show*; middle: Gerrit Rietveld's *Zigzag stool*; right: Carl André's *Bloody Angle*

Objects in the Stedelijk Museum’s collection with a significant surface contact (see Figure 8 for examples) would cause a large insulated surface on the floor with subsequent heating of the lower part of these objects.
